From: Catroin, Estima
To: Misson, State; Bhostriberry, Willia
Subject: Wilcox Information
Date: Misson, June 26, 2017 20:314
Attachments: Frostr, Ob. Sample Speaks to ERT Task 5 page Doc report and image002 prog image002 prog image002 prog imageous and lead areas and

Serve-Bill, here is some additional information related to the two areas we spoke about this morning. All data from the Removal Report, the ERT report, and the Remedial work is in Scribe. I am getting confirmation from EA, but I do not believe that waste was visually seen in any of the soil boings

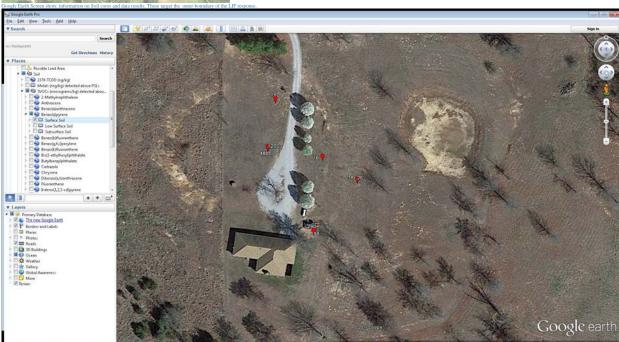
Figure: Property 006: information on visual observation of waste material. (Removal Report, data collected May/June 2017)

The geoprobe maximum depth was 8 feet bgs or refusal (i.e., bedrock). Visual observations noted sludge present at 12inches and 18inches. No data collected.
